Manhole Inspection Summary

Manhole # S09AA2002MH

Insp Date: **7/17/06 11:14 AM**

Location Address: **5819 STUART AVE**

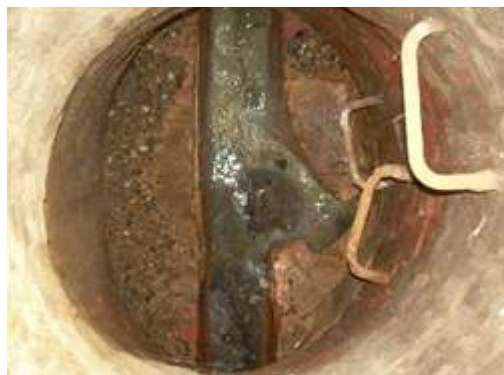
Top View

Corroded steps. Evidence of surcharge - Bench debris. Channel debris.

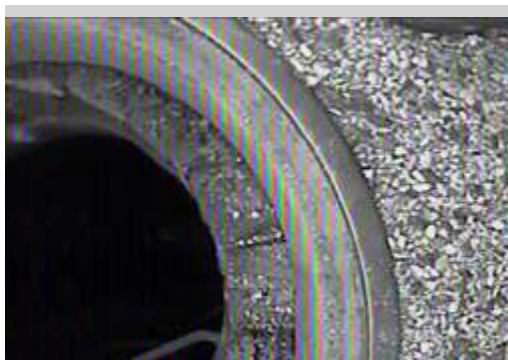
Defect

Frame offset. Adjustment deterioration and infiltration.

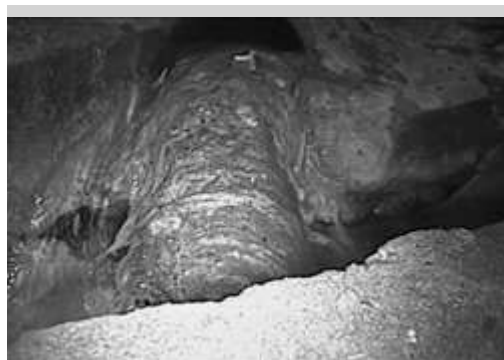
Defect

Debris/Grease inside pipe.

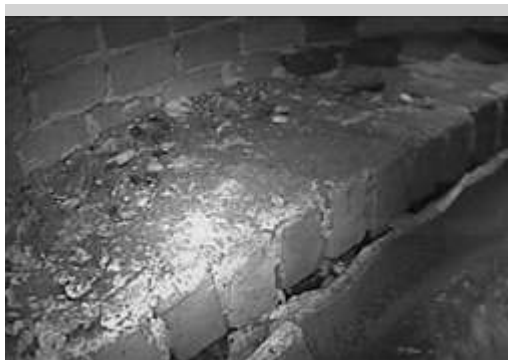
Defect

Bench and Channel deterioration..

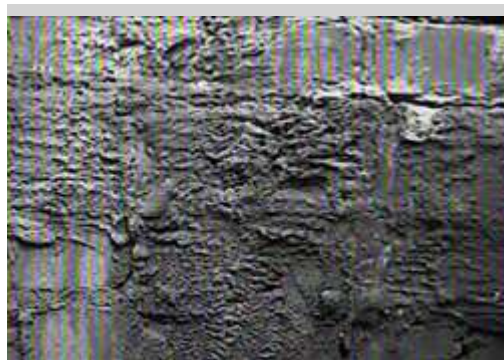
Defect

Corbel infiltration.

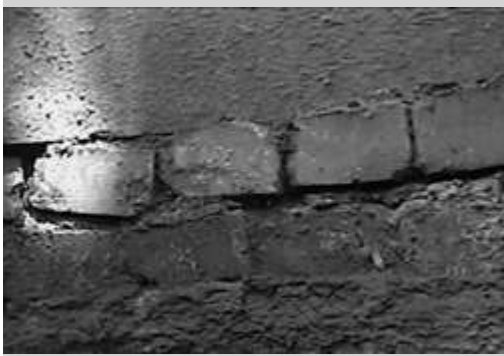
Defect

Frame leaks. Adjustment deterioration and infiltration.

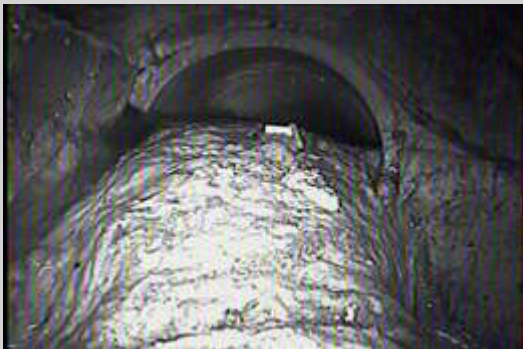
8 in. Circular Gravity Sewer Pipe In @ 4 O'Clock

Deposits: ☐ None ☐ Mud ☐ Sludge ☒ Debris ☒ Grease

Silt Depth: **5** (in.) Deposits Extent: **Heavy**

Infiltration: **Evidence** Pipe Seal Cond: **Unknown**

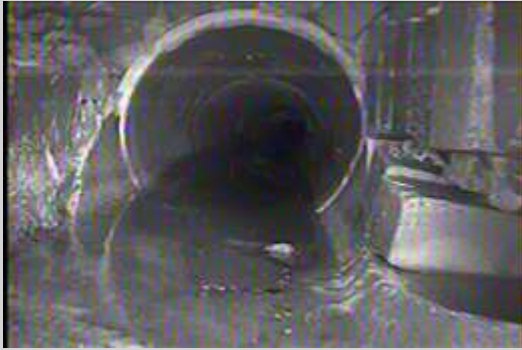
Pipe In @ 6 O'Clock

Channel deterioration.

Infiltration: **Evidence**
